Prescott Forwarders' Museum Condition Study

JOB#: 17202 | November, 2017
SUBMITTED BY: EVB Engineering &
Architecture49 Inc.

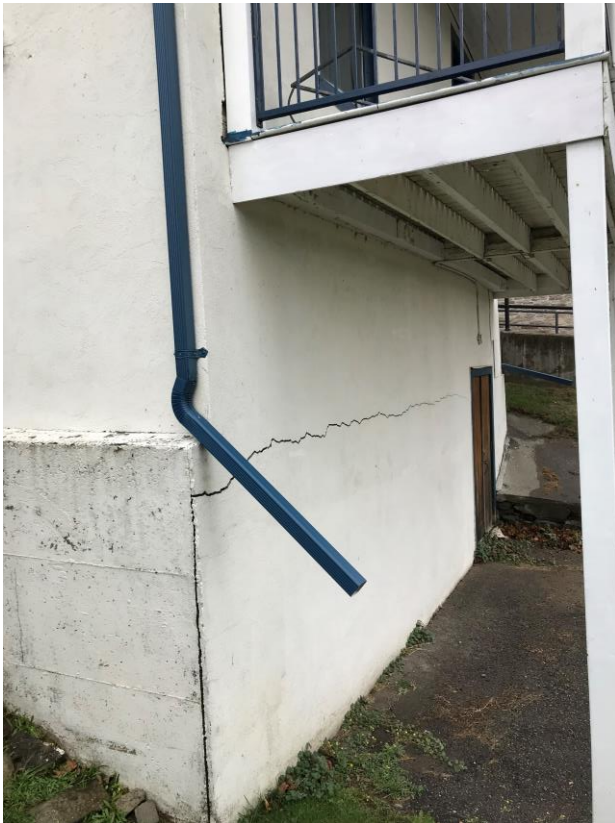
Photo 1.1A / Photo 2.1A

Significant wall cracking, gaps and movement joints are visible on all sides of the building (1.1A and 1.1B). The foundations were not excavated as part of this investigation. However, based on the previous 2013 report and photos, the above grade portion of the stone rubble walls are in poor condition. The below grade foundations are of similar construction and are expected to be in need of extensive repair following years of freeze thaw action, shifting and water infiltration that has caused mortar loss, crumbling and cracking of the stones. Full depth excavation on each side of the building to expose the exterior foundation walls, removal of the parging/stucco finish and re-pointing, and partial outer wythe stone replacement followed by waterproofing/drainage/foundation insulation measures is recommended.

Based on photos from the 2013 report and understanding that the recommended remediation works were not completed, the above grade stone rubble walls remain in poor condition and continue to deteriorate. Significant cracking and gaps are visible in the stucco finish as noted in section 3.1 (refer to photos 2.1A and 2.1B). If the Town elects to proceed with remediation of the Museum, further investigation into the wall conditions are recommended via stucco and plaster removal on each side of the building on both the interior and exterior to establish the full extent of required repairs. Replacement of window and door lintels is recommended as part of the wall remediation work. Wood rot was observed in an exposed lintel as part of the previous investigation completed in 2013. A portion of the second-floor timber joists have been damaged by fire exhibiting charring and loss of section (refer to photos 2.2A and 2.2B). In conjunction with timber joist replacements of this area, an overall floor capacity engineering review of the ground floor, second floor and roof structure is recommended to ensure conformance to current Ontario Building Code load requirements (photo 2.3A). Ground floor reinforcing was previously completed with the addition of new floor joists and a center steel beam added. A design review of the south balcony floor and roof framing is recommended. Additional floor joists were added but improperly connected with double joist hangers each end (refer to photos 2.4A and 2.4B).

If the Town elects to proceed with remediation of the Museum, further investigation into the wall conditions is recommended via excavation and stucco removal on each side of the building on both the exterior and interior face of the foundation to establish the full extent of required repairs.

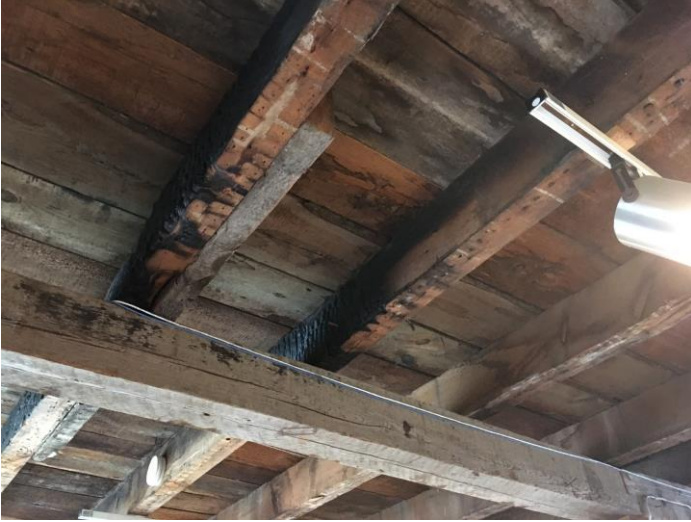
Photo 2.2A

The ground floor is generally in good condition. There are signs of fire damage to timber floor joists around the fireplace (second floor framing – refer to photos 2.2A and 2.2B). The fire place

2.0 WALL, ROOF AND FLOOR FRAMING – STRUCTURAL					
2.1	Above grade exterior wall assembly repairs	High	< 1 yr	\$200,000	2.1A, 2.1B
2.2	2 nd Floor Framing Repairs – Charred Timbers	High	< 1 yr	\$4,000	2.2A, 2.2B

- Based on the above investigation, expose above grade stone walls. Stabilize with repointing and partial stone replacement;
- Replace timber lintels;
- Replace 2nd floor timbers charred in fire and complete design review of the ground floor, second floor and roof framing;

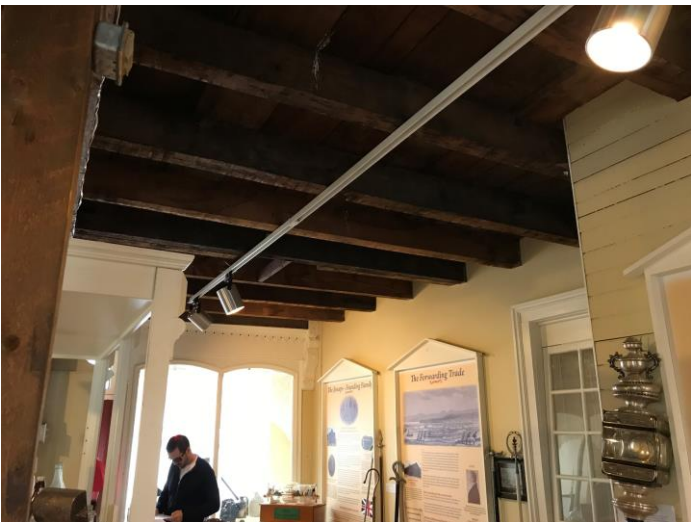
Photo 2.3A

2.3	Engineering review Ground, 2 nd floor and roof framing	Medium	< 3 yrs	\$6,000	2.3A
2.4	Balcony Engineering Review and Repairs	High	< 1 yr	\$8,000	2.4A, 2.4B

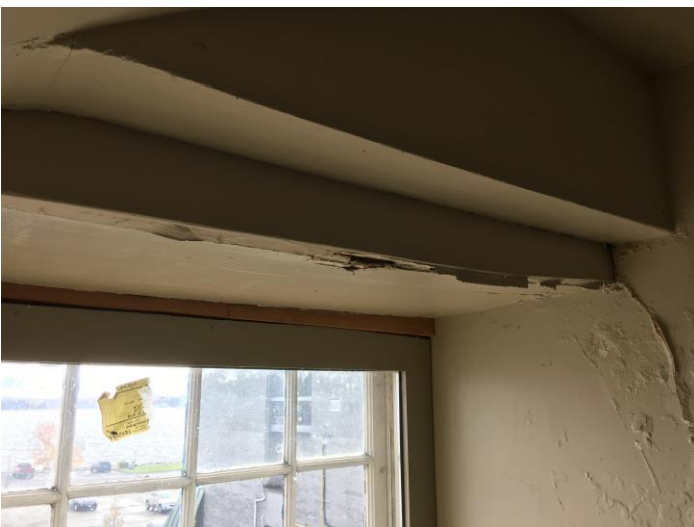
Photo 2.5A

2.5	Window/Door Lintels	Medium	< 3 yrs	See 2.1	2.5A
SUBTOTAL				\$218,000	
3.0 BASEMENT					
3.1	North Corner/waterproofing	High	< 1yr	See 1.1	3.1A, 3.1B
3.2	Service room fire separation	High	< 1yr	\$5,000	3.2A
SUBTOTAL				\$5,000.00

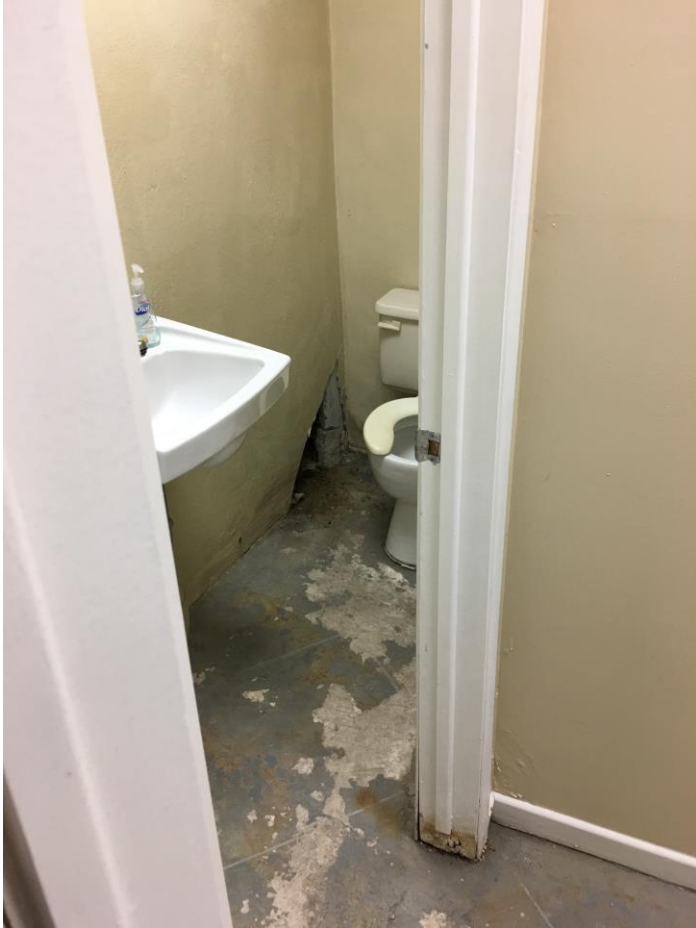
Photo 3.1A

The basement contains a musty smell and shows signs of prior water infiltration. Specifically, inside the north-east corner washroom there are signs of water infiltration from the corner of the room likely seeping through the stone foundation. Foundation Waterproofing and a drainage system is recommended around the entire perimeter of the building (refer to photos 3.1A and 3.1B).

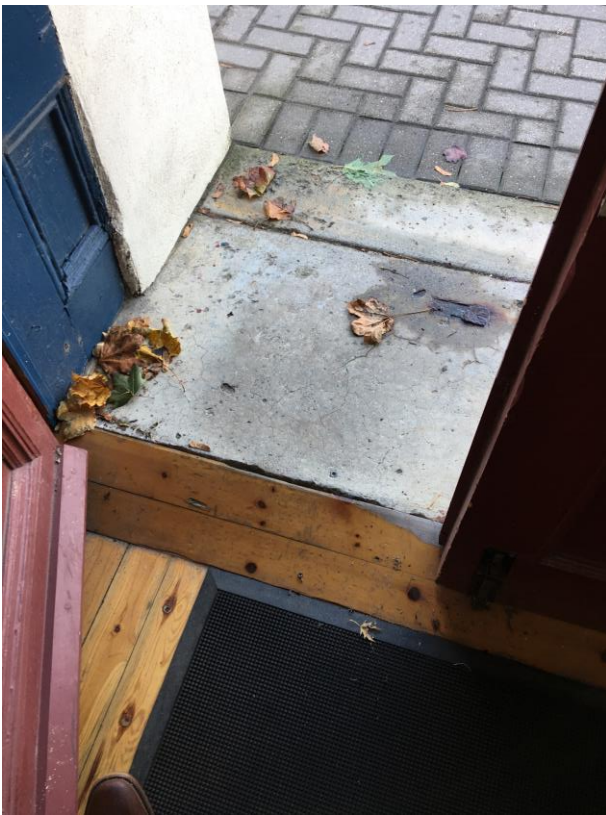
Photo 4.2A

has been decommissioned and should remain out of service pending the completion of safety upgrades. The front north entry of the building exterior is at a higher elevation than the ground floor with a sloped wooden door sill providing the potential for water infiltration (refer to photo 4.2A). An existing exterior trench drain along the sidewalk was noted at this location..

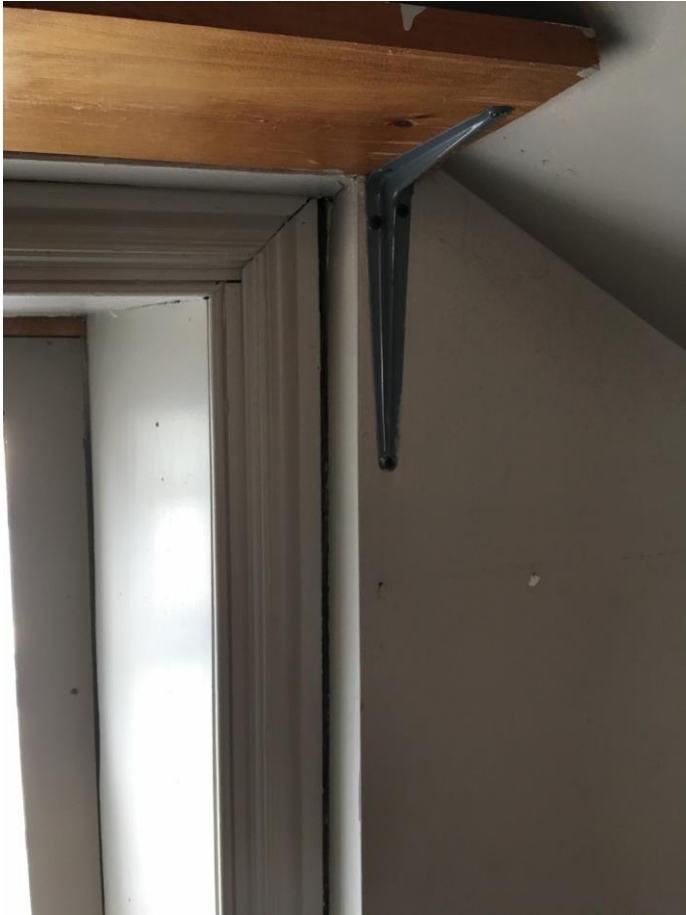
Photo 5.1A

The second floor is generally in good condition. Misalignment of windows and trim and cracking of finishes around the windows are indicative of building movement/settlement refer to photos 5.1A, 5.2A). There is evidence of water infiltration at the south fireplace possibly due to improper flashing construction at the chimney. Note the flashing could only be inspected from ground level. The staircase guardrail (30" high) does not meet current OBC height requirements. Headroom clearance is inadequate due to the sloping ceilings.

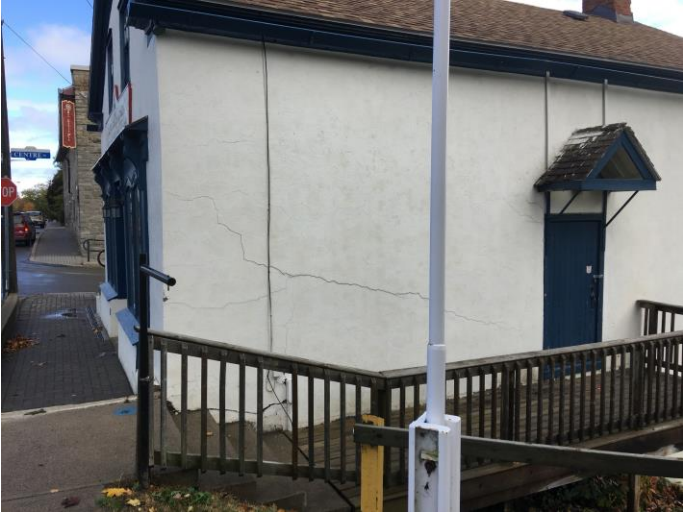
Photo 6.1A

The exterior stucco exhibits significant cracking on all elevations (refer to photos 6.1A, 6.1B, 6.1C). A portion of the east elevation stucco material has been removed and cladded with painted plywood that is showing signs of buckling. The south exterior balcony floor structure appears poorly constructed and it is recommended that balcony access be restricted until an engineering review and any required upgrades are completed. The southeast balcony post is buried below grade level. This should be elevated above grade to prevent wood rot.

- Remove exterior stucco (renovate stone masonry walls);
- Refinish windows;
- Inspect and repair chimney flashing;
- Decommission the fireplace;
- A designated substance survey (DSS) is recommended.

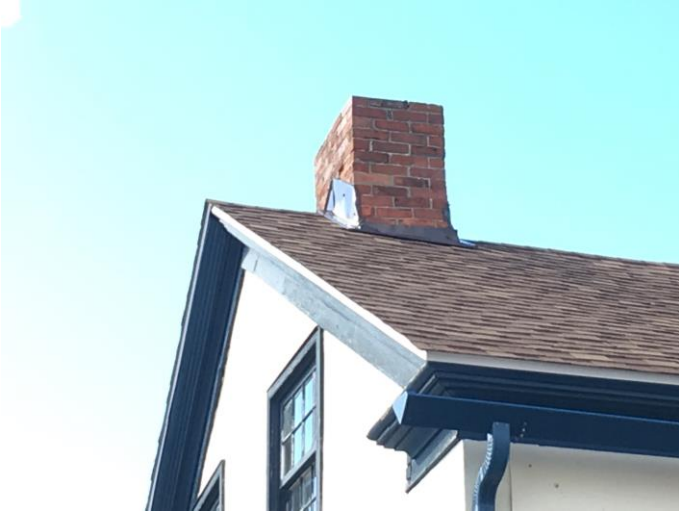
Photo 7.1A

The main roofing appears to have been recently replaced and is in good condition. The roof above the west entry is showing signs of deterioration and replacement is recommended (photo 7.2A). It would appear that the balcony roofing was replaced at the same time as the building roofing. The flashing for the chimney appears to be improperly constructed causing water infiltration at the second-floor ceiling. Note the flashings could only be inspected from ground level. Reconstruction of the flashing is recommended. (refer to photos 7.1A, 7.1B)

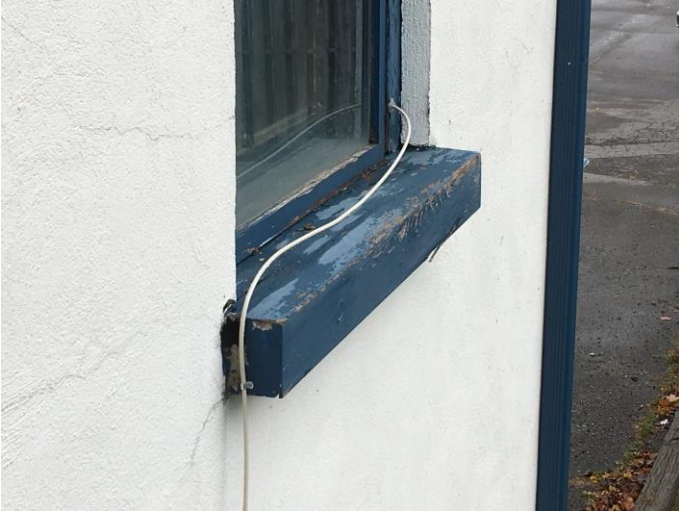
Photo 8.1A

All windows appear to be in acceptable condition. Recommend refinishing of exterior windows that are showing signs of weathering to ensure protection from deterioration/rotting (refer to photo 8.1A).

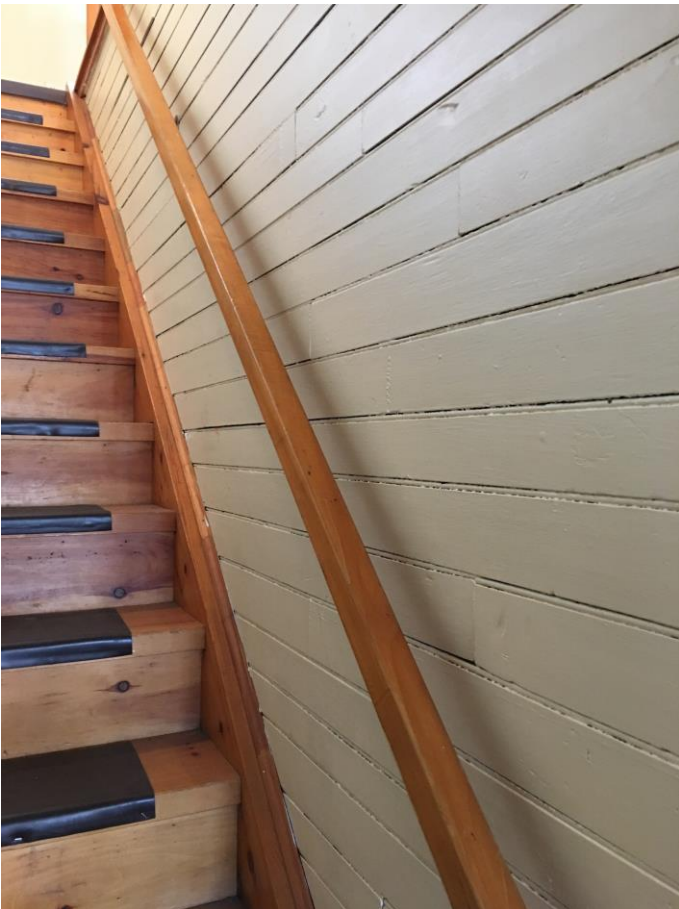
Photo 9.1A

The interior staircase to both the basement and the second-floor levels appear sound however the handrails for these staircases do not meet current OBC height requirements (refer to photo 9.1A, 9.1B).

- Balcony engineering review and reinforcement. Restrict access until work is complete;
- Provide proper fire separation of service room equipment;
- Replace guards and handrails;

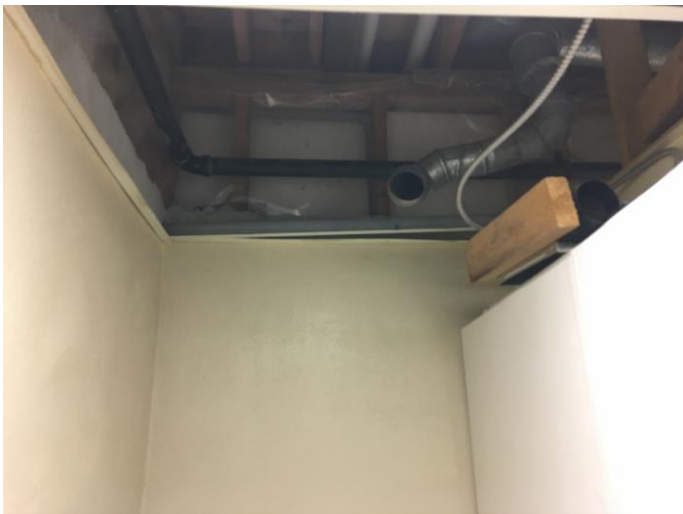
Photo 10.1A

The washroom facilities and fixtures appear to be in working condition however, the flooring within the washrooms show signs of water damage/infiltration and the ceilings have been removed. Due to the moist conditions of the basement the potential for mould exists and should be investigated further. The water appears to enter via at the northeast corner of the north washroom (refer to photos 10.1A).
