DESIGNATED SUBSTANCES SURVEY

FORWARDERS MUSEUM AND VISITORS INFORMATION CENTRE - 201 WATER STREET, PRESCOTT, ON

NOVEMBER 9, 2017

PROJECT NO.: 171-15057-01
DATE: NOVEMBER 2017

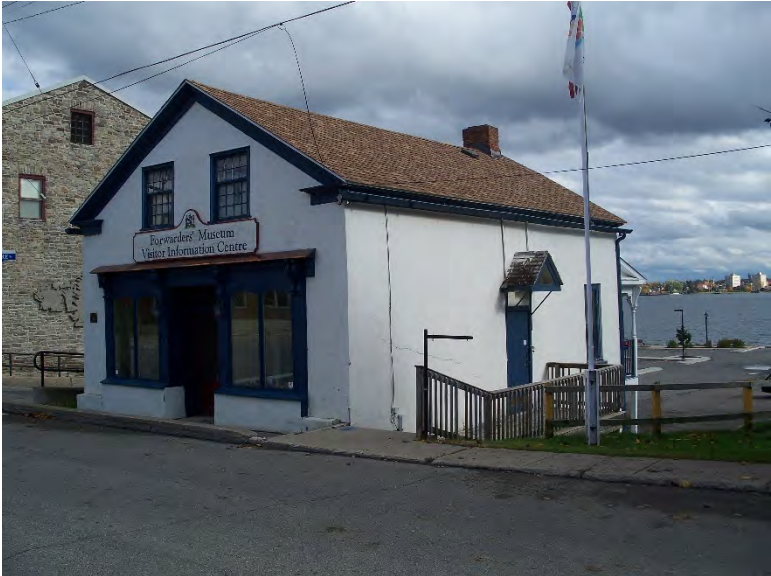
PHOTO NO.	MATERIAL DESCRIPTION & LOCATION	PHOTO
1	<p><u>Forwarders Museum and Visitor Information Centre</u> (“subject building”) building exterior.</p>

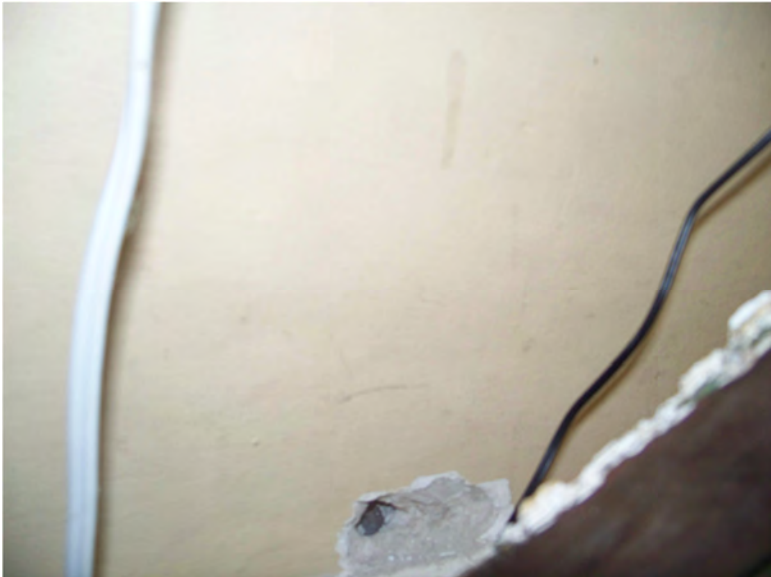
2	<p><u>Plaster - Type A, white and grey coat</u> (Non-Asbestos) observed in Room 1 and throughout the subject building.</p>

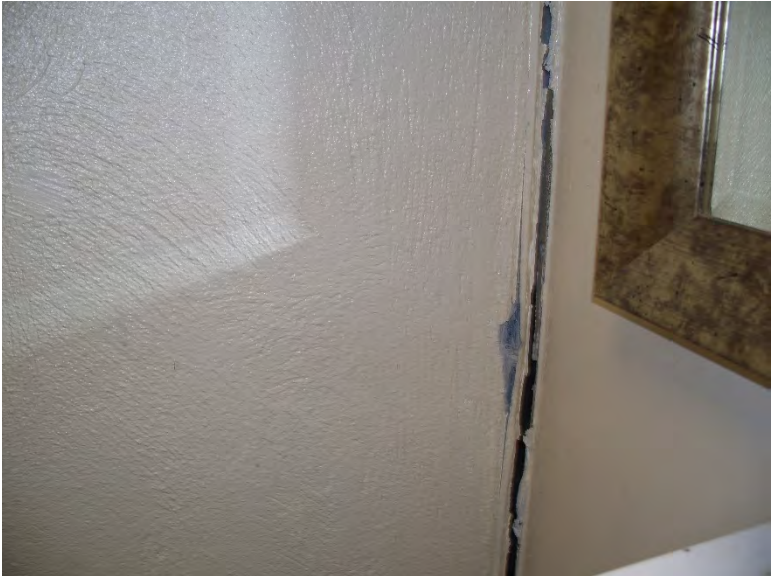
PHOTO NO.	MATERIAL DESCRIPTION & LOCATION	PHOTO
5	<p><u>Plaster - Type B, grey coat only</u> (Non-Asbestos) observed in Rooms 10, 11, 12, and 13.</p>

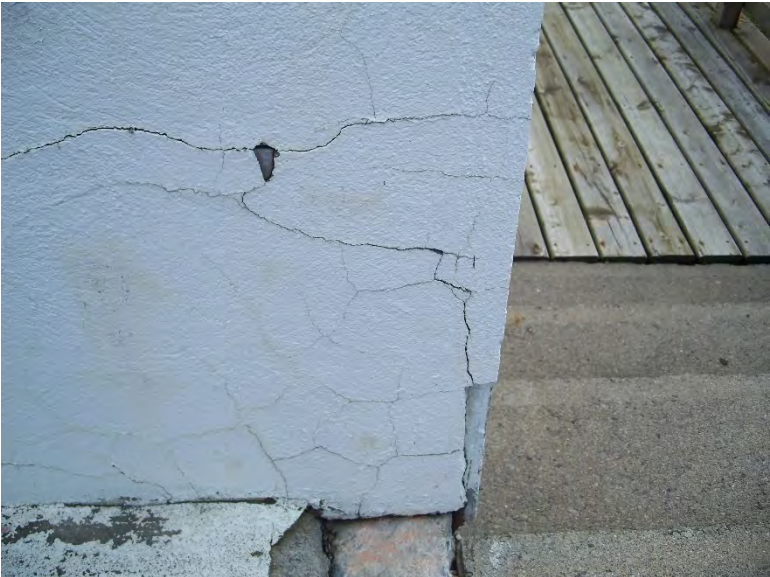
6	<p><u>Stucco - Type B, exterior wall stucco</u> (Non-Asbestos) observed on the subject building exterior.</p>
